## Application of the Waste Landfill Quality Index (IQR): Study in an area in southern Brazil

## 2.2. IQR Determination (CETESB, 2007)

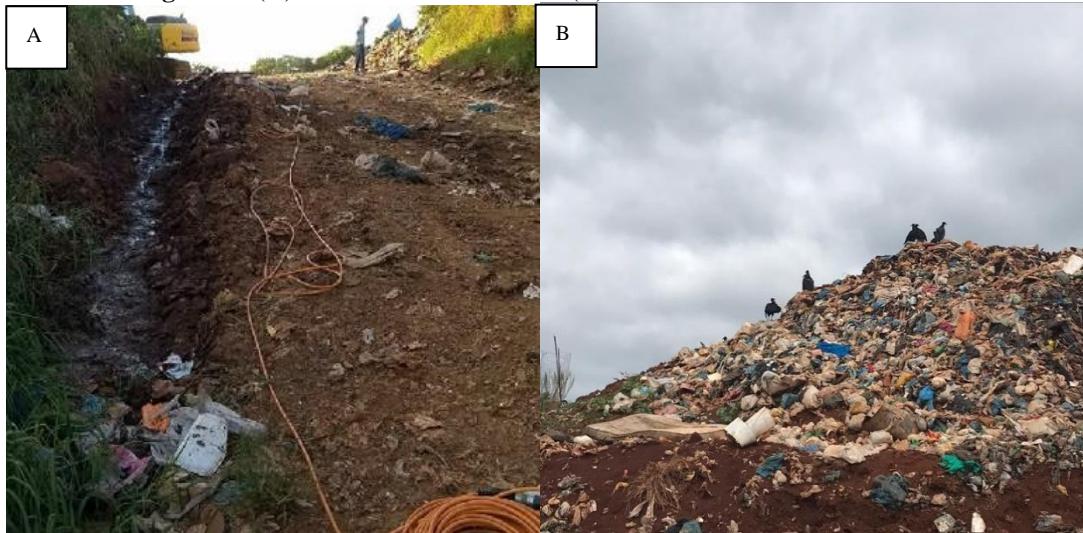
The application of the IQR (CETESB, 2007) on the first visit to the study area showed a value of 8.4, indicating that the structural conditions are adequate (Table 2) (CETESB, 2007). It observes the leachate and, consequently, inefficiency in the drainage system of this material as inconsistencies of the first visit (Figure 2).

**Figure 2 - (A) Presence of leachate and (B) birds at the site on the first visit.**

The IQR value (CETESB, 2007) was 9.2 (adequate condition) in the second visit. Note the changes due to the non-existence of leachate outcropping and adequacy of the drainage system. The other inconsistencies seen on the first visit continue the second (presence of birds, absence of geotechnical monitoring system, presence of flies).

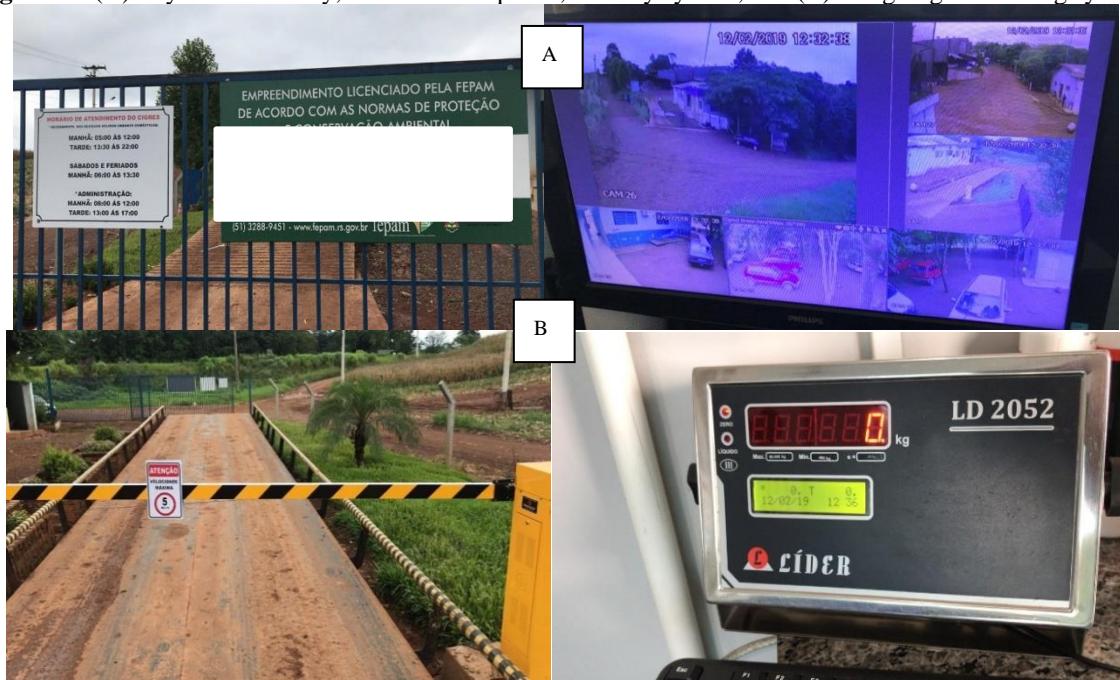
The operation was in good condition in both surveys. In general aspects, there is fencing around the entire bordering area and an efficient security system (Figure 3A). This system consists of a gate with electronic closure and an internal security monitoring network, which aims to identify the presence or circulation of unauthorized persons in the interior area. In addition, the enterprise under study has a weighing and cubing system (Figure 3B), facilitating controlling the input and output of waste and assisting in demands that refer to the management of the landfill.

**Figure 3** - (A) Physical boundary, identification plates, security system, and (B) Weighing and cubing system.

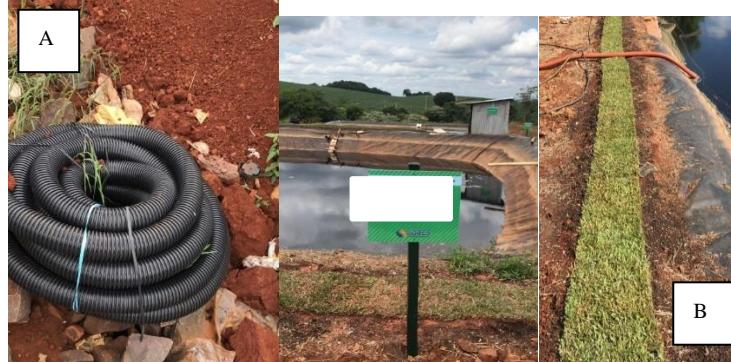
As for the leachate drainage (Figure 4A), the effluent recirculates from the lagoons to the cells after its preliminary treatment (Figure 4B). The reinjection of percolated liquid into the mass of waste already landfilled facilitates the decrease of constituents by biological activity and physical-chemical reactions inside the landfill (Pires, 2002). According to Pires (2002), the recirculation of leachate reduces its volume due to loss through evaporation. Observes the leachate treatment occurs in three natural lagoons: two anaerobic and one facultative.

**Figure 4** - (A) Leachate drainage system and (B) effluent treatment ponds.

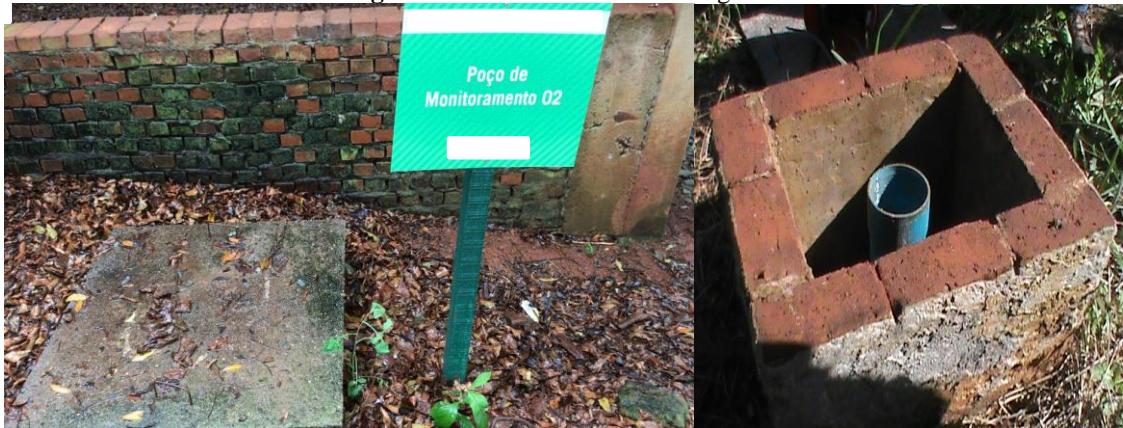
Regarding environmental monitoring, in the study area, there are six monitoring environments (four are in operation) (Figure 5). These build environments (wells) are following the technical standards established by NBR 15.495-1/2007 (ABNT, 2007) and 15.495-2/2008 (ABNT, 2008). It performs quarterly collection for qualitative groundwater monitoring of a series of physical, chemical, and biological water quality parameters.

The NBR 15.849/2010 (ABNT, 2010) indicates that it is necessary to have a groundwater monitoring network composed of at least three wells downstream and upstream of the activity in landfill areas. In this sense, the site presents the minimum condition, indicating the drilling of more monitoring wells, especially in the underground flow direction.

**Figure 5 -** Groundwater monitoring wells.

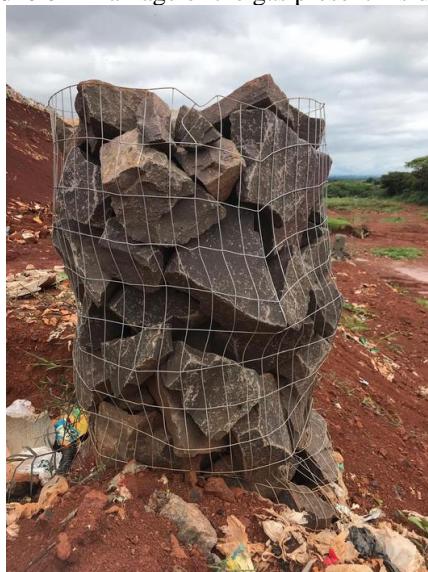
The gas drainage system shows in Figure 6, where the gas in the collection is released directly into the atmosphere (Figure 5), not the burning, for operational and financial reasons. According to Brito Filho (2005), the gas generation capacity depends on several factors: waste composition, humidity, particle size, age of the waste, pH, temperature, and others.

**Figure 6 -** Drainage of the gas present inside the landfill.

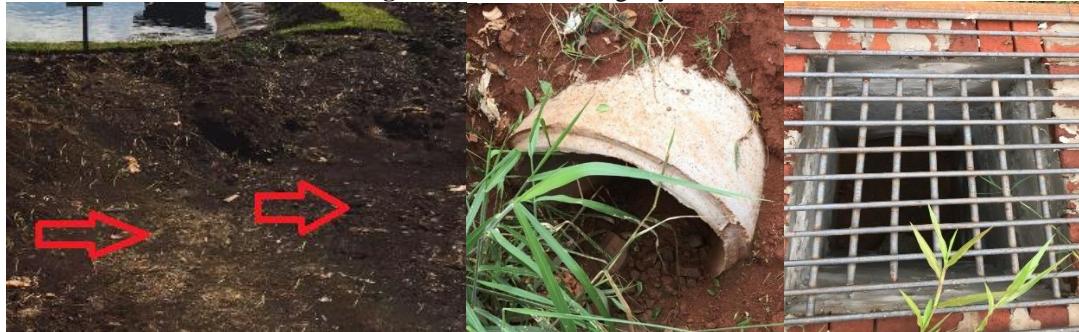
The existing rainwater drainage system aims to avoid directing the water to the leachate treatment ponds and its accumulation in the area. Instead, it collects the rainwater in the covered areas to be used later in washing floors or irrigation. Moreover, in the other regions, drainage is performed utilizing sub-surface drains and subsequent forwarding to the external area, as shown in Figure 7.

**Figure 7** - Storm drainage system.

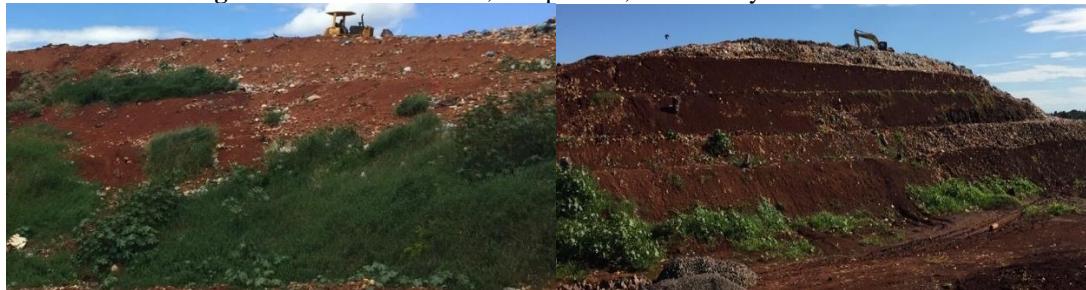
The covering of the waste is weekly or more frequently. It uses the soil from a side area, and a hydraulic excavator performs the compaction and accommodation of the garbage in conjunction with a tracked tractor (Figure 8).

**Figure 8** - Accommodation, compaction, and overlay of the waste.
